AGAM-P (M) (18 Jul 69) FOR OT UT 692079

SUBJECT: Operational Report - Lessons Learned, Headquarters, 588th Engineer Battalion, Period Ending 30 April 1969

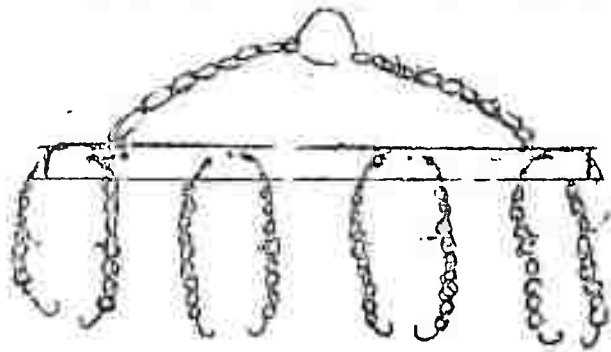
(2) Evaluation: The 20 ton crane with a hook and the 5 ton wrecker are used for loading. Material in 55 gallon barrels presents a particular time consuming task when loaded one at a time.

(3) Recommendation: By welding a 10' bar to a loop and placing 4 sets of chains on the bar, 4 barrels can be loaded in practically the same amount of time as one.
